JENSEN-HEALEY SERVICE BULLETIN

No. JH 205

MARCH, 1974

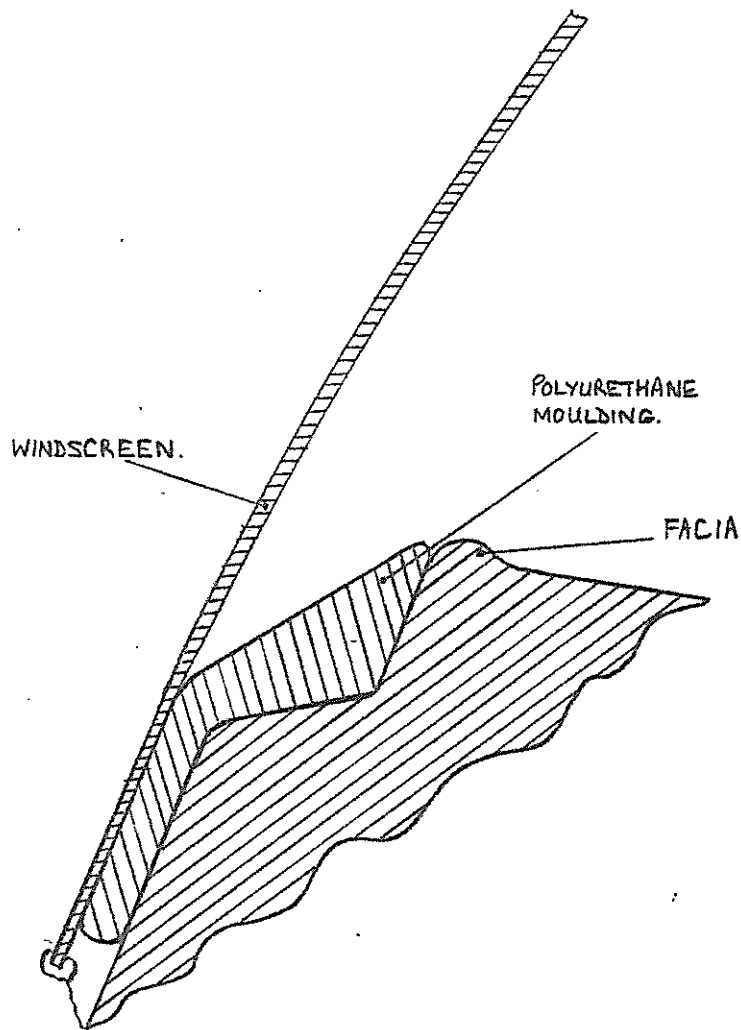
FIG. 1. FACIA MODIFICATION.

Because of isolated reports of the facia material lifting at the front edge, a service fix has been introduced. If this fault occurs, a polyurethane moulding is available and should be inserted between the facia and windscreen as shown on figure 1 attached using Evostik or Dunlop 1358 adhesive to keep in place. The adhesive should be applied to the moulding and allowed to dry completely, and then applied to the top of the facia and left for between two and three minutes, after which time the moulding should be pushed into position.

The moulding may be ordered direct from Jensen Motors Ltd., quoting Pt. No. 97492 (coarse grain) or Pt. No. 97491 (fine grain).

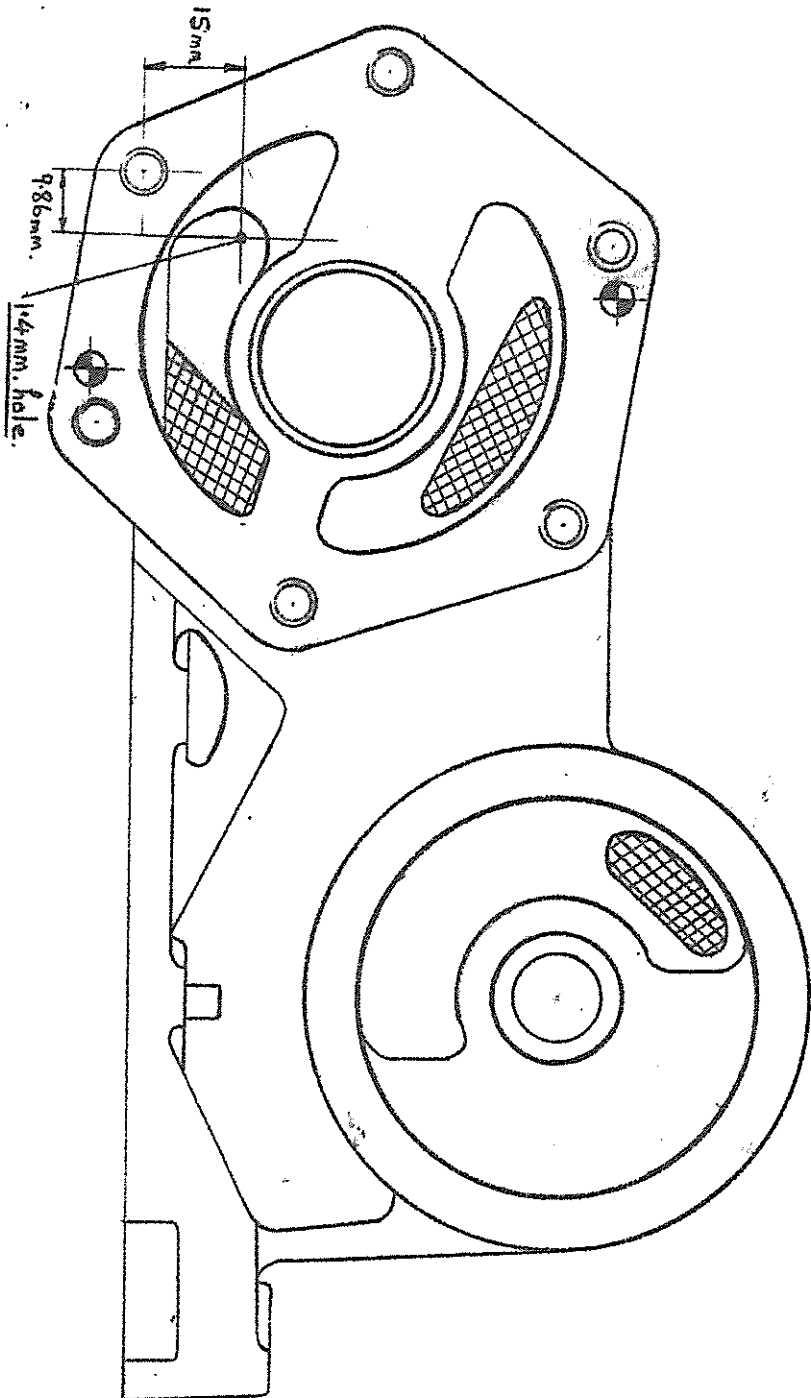
FIG. 2. LOCATION OF AUXILIARY HOUSING AIR BLEED HOLE.

10. MODEL : JENSEN-HEALEY. ALL VARIANTS
GROUP : ENGINE
SUBJECT : OIL PRESSURE DELAY

To decrease the oil pressure build up time, an air bleed hole has been incorporated in production (at Chassis No. 14875) on the pressure side of the oil pump housing within the auxiliary housing. This hole will allow air trapped in the oil galleries to be pumped out and therefore assist pump priming.

Should a problem of delay in oil pressure build up be experienced, the auxiliary housing may be modified as follows:-

- (i) Remove camshaft belt.
- (ii) Remove the auxiliary housing from the engine.
- (iii) Remove the pump from the auxiliary housing
- (iv) Remove the circlip retaining the oil pump gear to the drive shaft and withdraw the gear.
- (v) Drill a 1.4 mm. (No. 54 drill) hole in the auxiliary housing as shown in figure 2 attached.

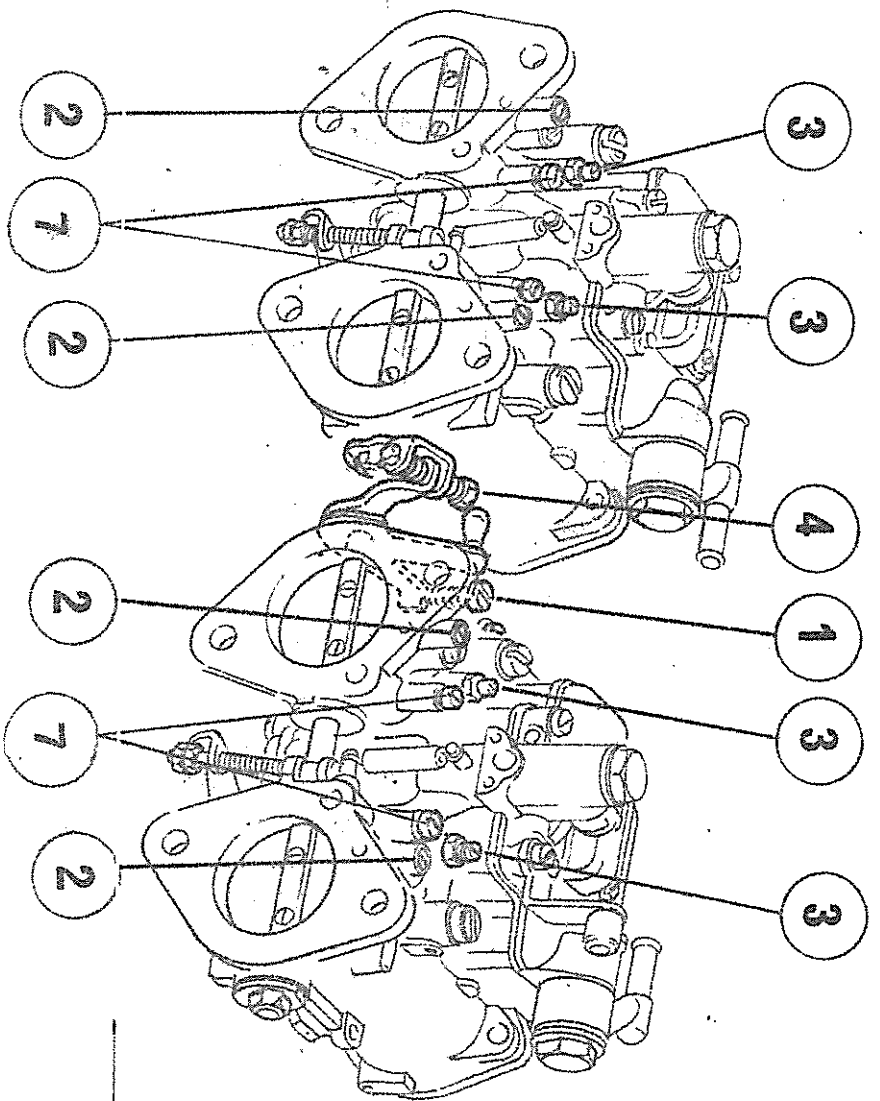
FIG 3 TWIN DELCO-ROMERO PHLA 40E
CARBURETTORS

REFER TO FIG.3 ATTACHED

If complaints are received of a "flat spot" occurring between 2,000 and 3,000 r.p.m. then this is probably due to a burr being present at the bottom end of the drilling in the idle jets.

- (a) Warm up engine to the normal operating temperature
- (b) Switch off engine and unscrew the central throttle stop screw (1) until it is visibly well out of contact with the lever extension. This allows the forward throttle butterflies to close completely.
- (c) Slowly screw in the central balance connecting lever screw (4); this forces the rear throttle butterflies to close and it will be seen that the rear carburettor throttle spindle is gradually closing while the forward spindle stays closed. Continue screwing in until the rear throttles are fully closed.

In this case the idle jets should be removed and a clearance drill, No. 75 (0.022", 0.55 mm.), pushed through each one by hand, from the top of the jet, to remove any burrs.

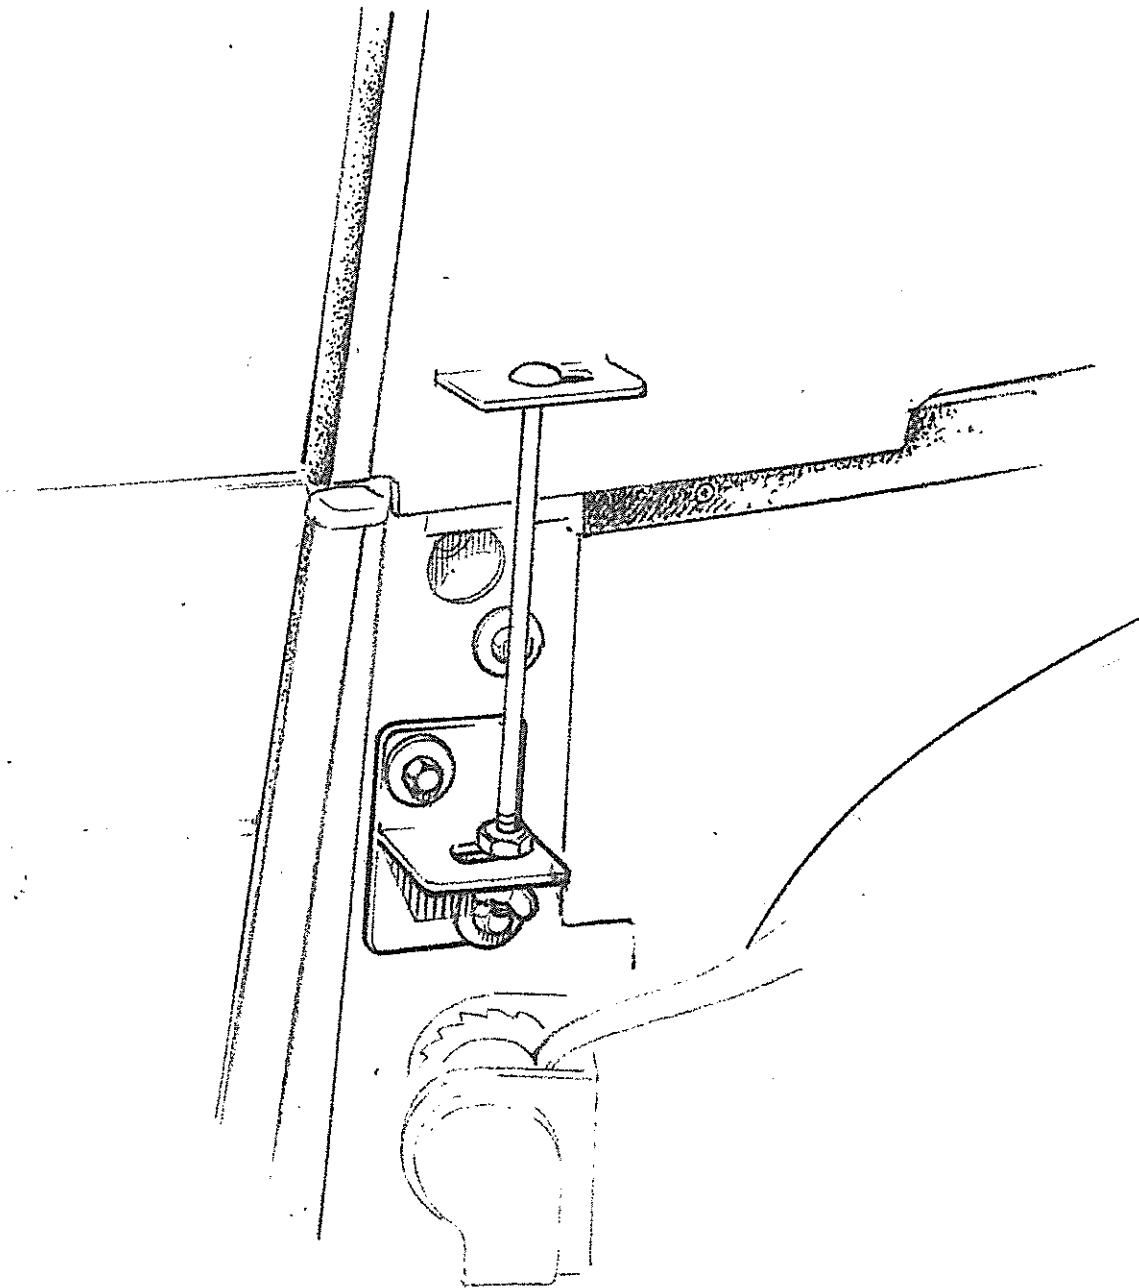
FIG 4. LOCATION OF ATTACHMENT BRACKETS.

It is advisable to completely remove the soft top and frame assembly. Release the header rail locking levers, detach the rear of the soft top from the retainers on the deck panel and remove three set screws from each frame mounting plate. The nut plates to which these set screws attach will drop down inside the wing if not held. They can easily be retrieved after removal of quarter trim panels. Fit the left hand and right hand attachment brackets using two of the original three set screws. Mount in the two lower frame attachment holes. See fig.4.

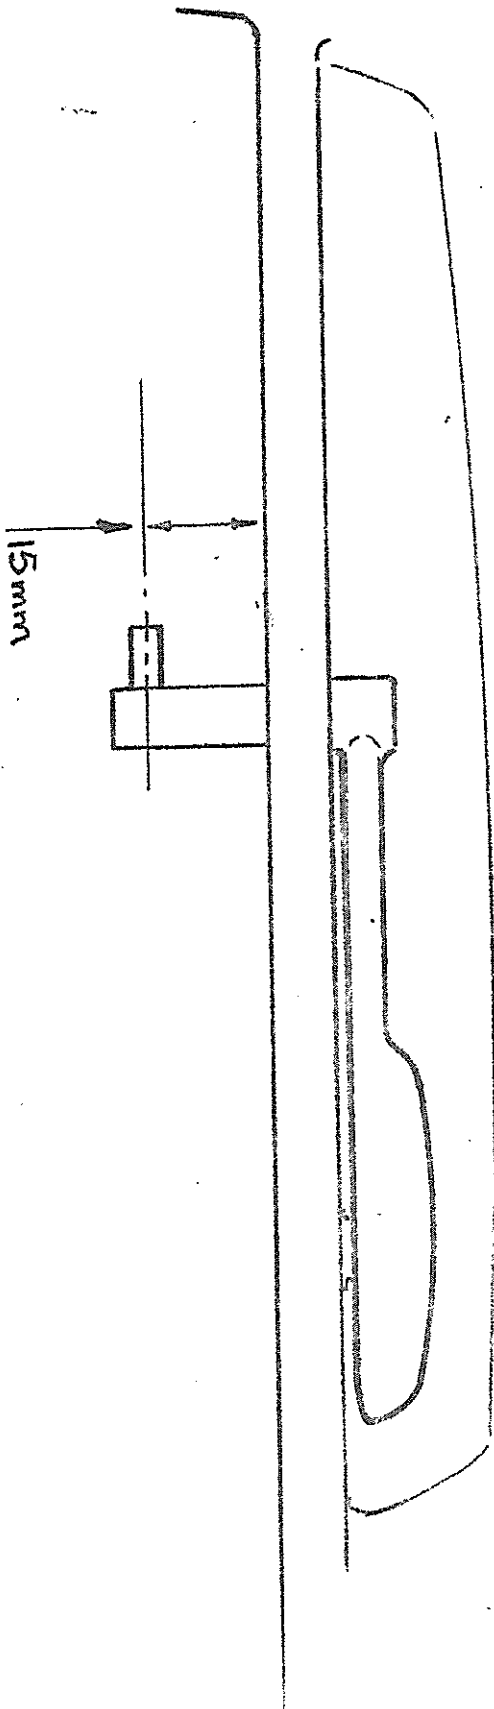
FIG. 5. ADJUSTMENT OF LOCKING LEVERS.

If water passes the sealing rubber in the header panel, check that the locking levers are adjusted as described in 'Hardtop Fitting Instructions'. The original rubber may be discarded and replaced by a seal of round section, as used on the rear deck panel seal.

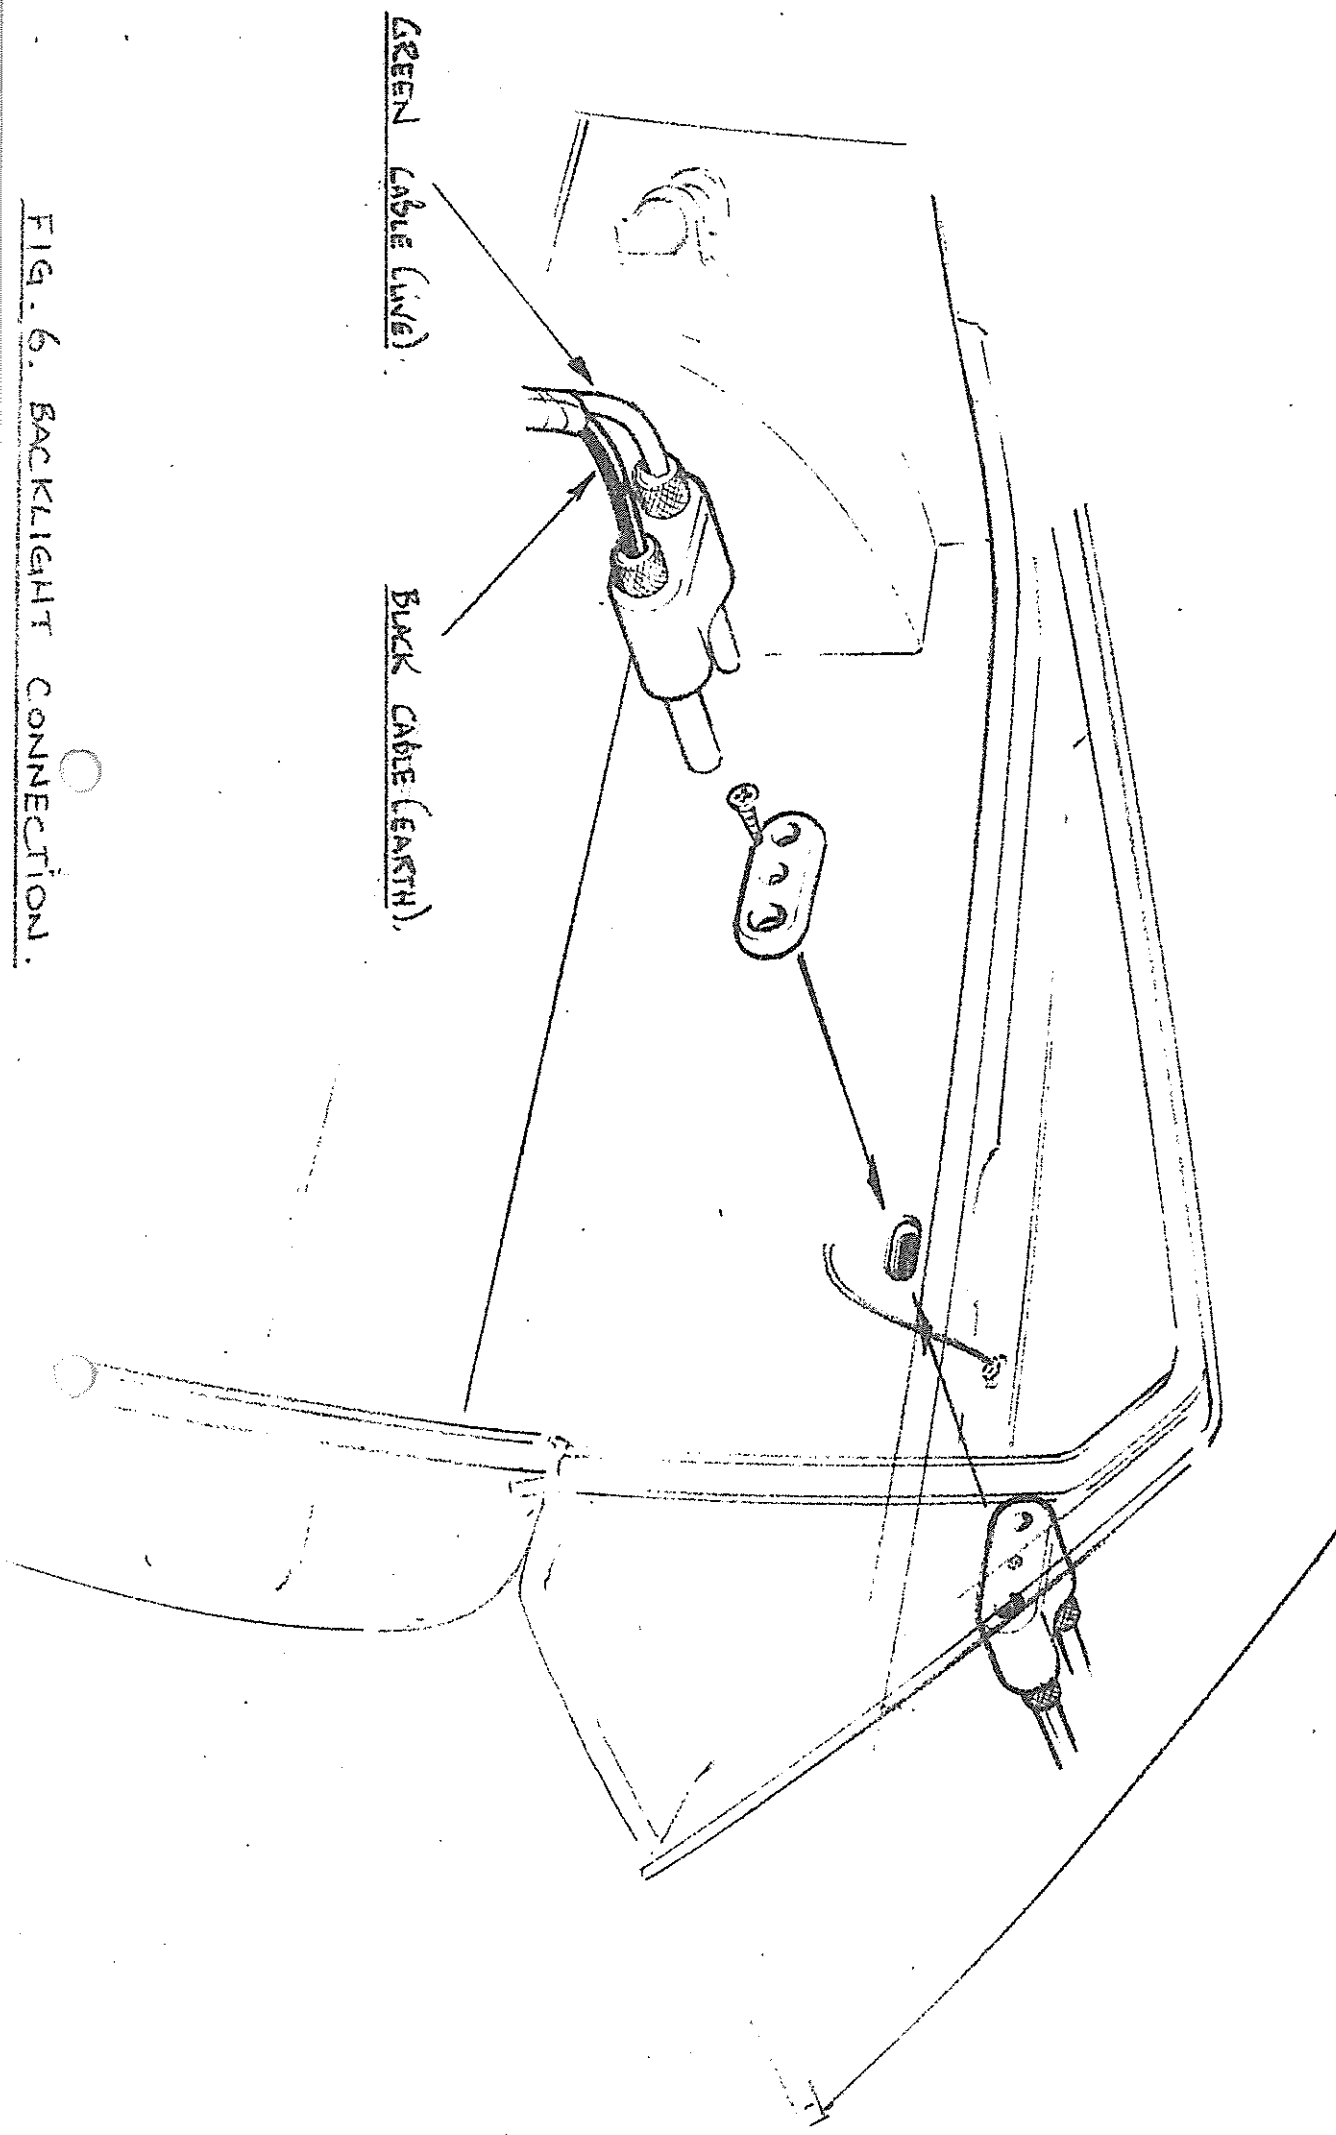
FIG. 6. BACKLIGHT CONNECTION.

Fit the plug, provided in the parts kit, to the hardtop wires, black (earth) to the large dia. pin and green to the small dia. pin. Remove the rear bulkhead trim panel from inside the car and detach the upper edge of the petrol tank casing from inside the luggage compartment. Fit the socket to the feed harness, both supplied in the parts kit, and secure in the rear bulkhead, see fig.6. A hole is provided in the rear bulkhead to allow the harness to reach the electrical pick-up point on the petrol pump. Detach the white feed wire from the petrol pump, fit a double adaptor 'Lucar' connector, refit the white wire and also the green backlight feed wire.

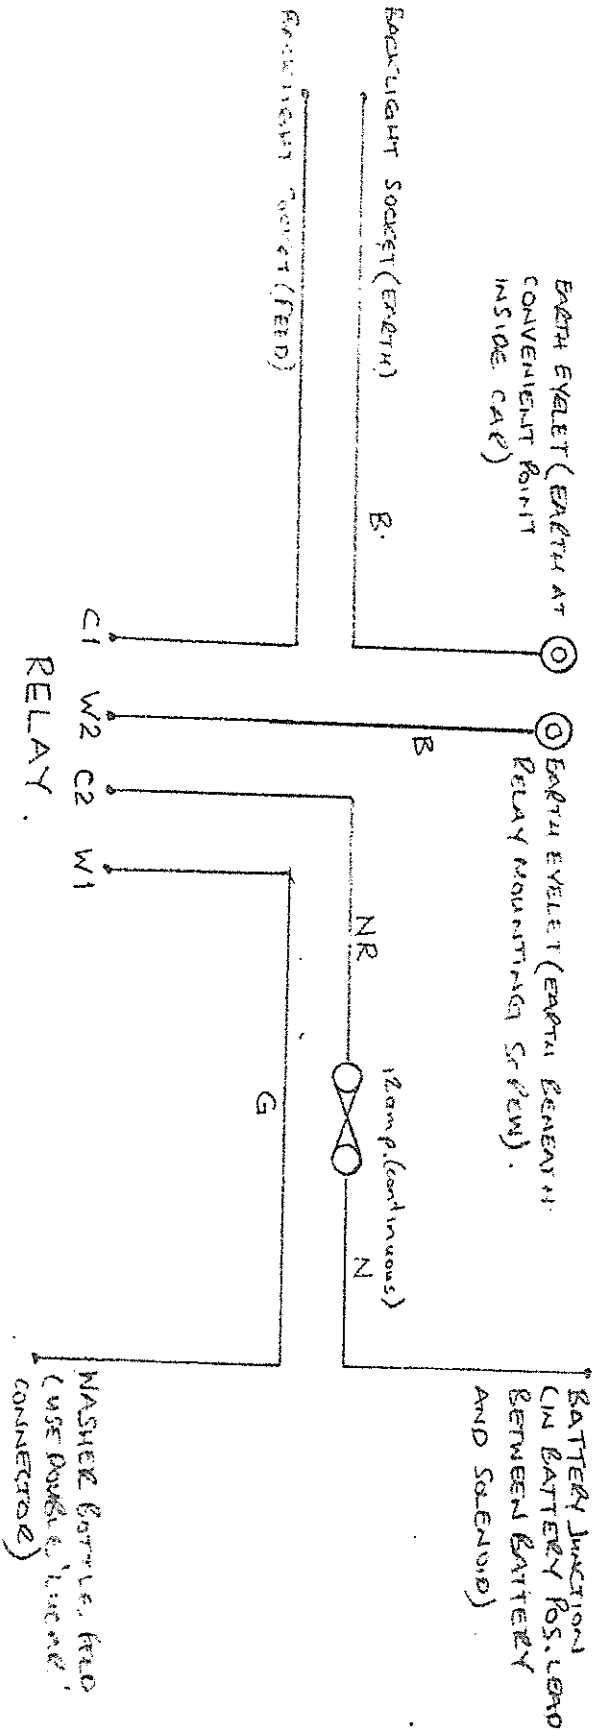
FIG. 7. BACKLIGHT HARNESS WIRING DIAGRAM.

Mount the Lucas 6RA relay alongside the fuse holder on the bulkhead with two screws provided. Connect in the backlight feed harness as shown in the attached wiring diagram, see fig.7., passing it through a bulkhead grommet. Detach one side of the rear bulkhead trim panel and run the harness along one edge of the floor carpets. Pass the harness behind the trim panel.

The backlight harness Part No. 97177 will shortly be available from Parts Department, and until it is, dealers may make up a harness as shown in fig.7.

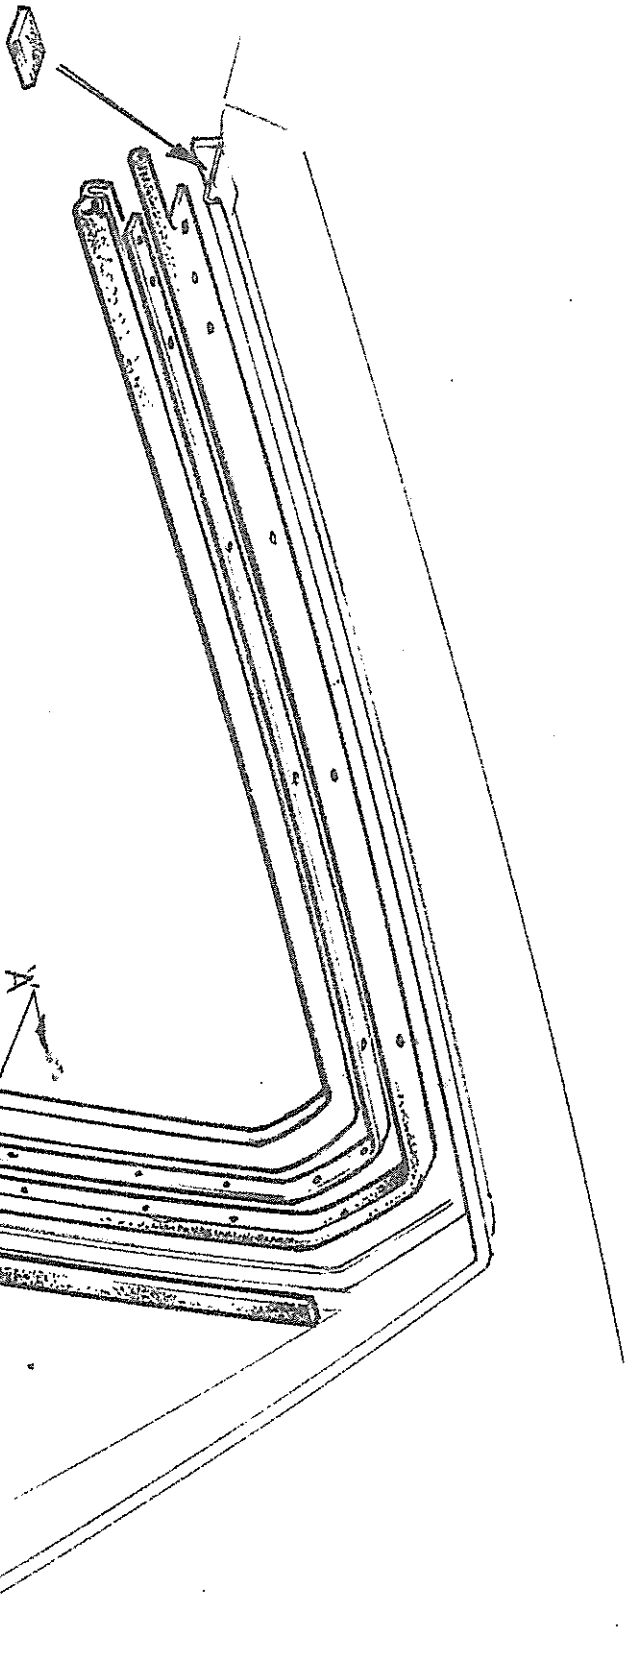
Offer up the seals as shown in fig.8., and using the retainers as a guide drill 1/16" holes through the fibre glass. The narrow end of the seal should be fitted at the rear. Before attaching the seals, stick the small square packers in position below the drip rails at the forward end of the hardtop as shown in fig.8. The secondary seals should extend approx. 1 1/2" past the hardtop at each end. Do not remove the round section part of the seal, but trim off the excess flat section. See fig.8. The holes in the rubber seals are oversize to allow for adjustment when the hardtop is refitted. The seals should be adjusted so that the round section follows the line of the droplight, but is positioned slightly outboard of the glass edge at the forward end, at the lower end the seal will lie behind the main window seal. See Sect. A.A. fig.8. Later cars have secondary seals fitted, but if water entry is experienced, these seals should be removed and the longer service type seals fitted.

Check the main droplight seal at the rear edge of each droplight. If the curve of the glass causes a gap to occur between the glass and seal, remove the main seal and glue a thin rubber packer strip to the fibre glass of the upright edge of each of the droplight apertures as shown in fig.8. Open out the main seal sufficiently to allow it to fit over the packer.
